**DeBordieu Colony Nourishment
Debidue Island, South Carolina**

Client:
DeBordieu Colony Community Association Inc
Georgetown South Carolina

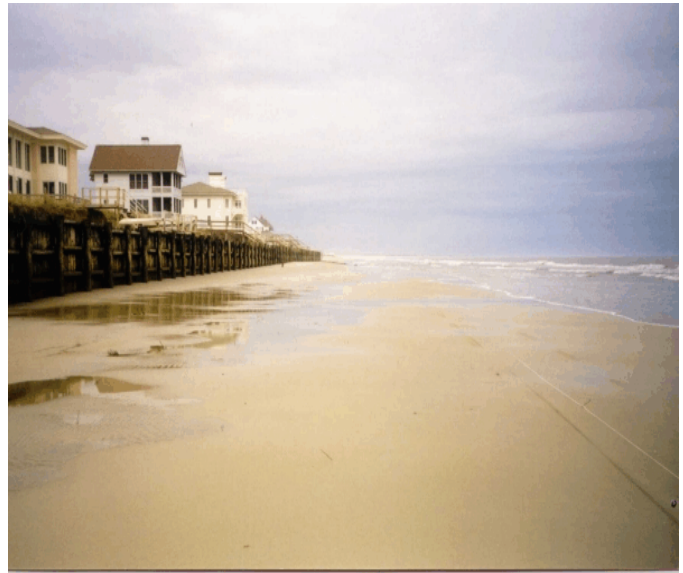
BEFORE NOURISHMENT

Debidue Island has a complex erosion signature owing to changes in the downdrift inlet. Closure of a secondary channel in the 1930s led to rapid spit growth and accelerated erosion around the center of the island. As development progressed in the early 1970s, erosion encroached directly on beachfront homes. Sand scraping was tried first, and then a timber bulkhead was constructed by the former owners to stop further recession. Loss of sand in front of the bulkhead soon left it exposed beyond safe design levels.

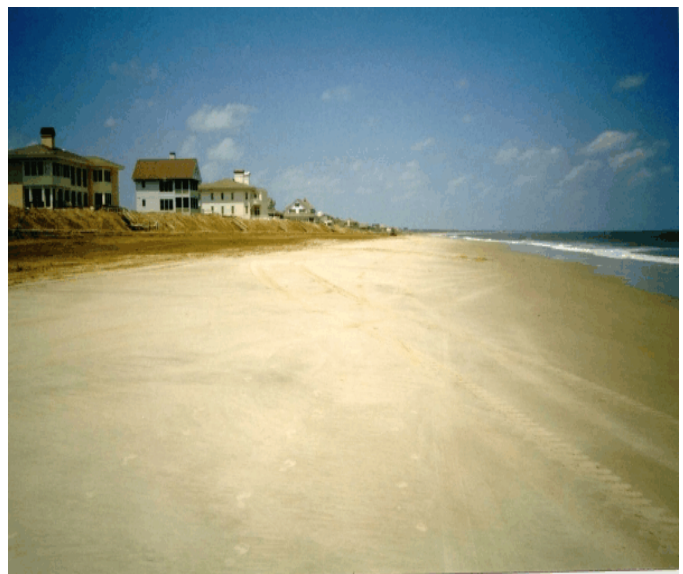
AFTER NOURISHMENT

Six months after *Hugo*, CSE's plan for nourishment was constructed. We predicted annual losses equaling 15 percent of the fill volume. This prediction was confirmed by surveys during the next six years.
